SUNGURBEY CAMİİ: Camiinin inşa kitabesi yoktur. Ancak 1335 yılı civarında yapıldığı düşünülmektedir. İlhanlı döneminde Niğde Valisi olan Sungur Bey tarafından yaptırılmıştır. Camiinin mimarı bilinmemektedir. Fakat mimber ile muhtemelen kuzey taç kapısının ahşap kapı kanatlarını Hoca Ebubekir, daha sonraki döneme ait doğu taç kapısının ahşap kapı kanatlarını ise Hacı Muhammed isimli ustalar yapmıştır. Niğde kalesinin güneybatı yönündedir.

SUNGURBEY MOSQUE: *There is no inscription on the mosque. Nonetheless it is thought it was constructed in around 1335. It was probably commissioned by Sungur Bey who was Governor of Niğde in the İlhanlı period. The architect is not known. But the pulpit and probably the wooden panels of the door in the northern crown entrance were done by craftsmen with the names of Hoca Ebubekir, and, for the later wooden panels of the door in the eastern crown entrance, Hacı Muhammed. It is located to the southwest of Niğde's Castle.*

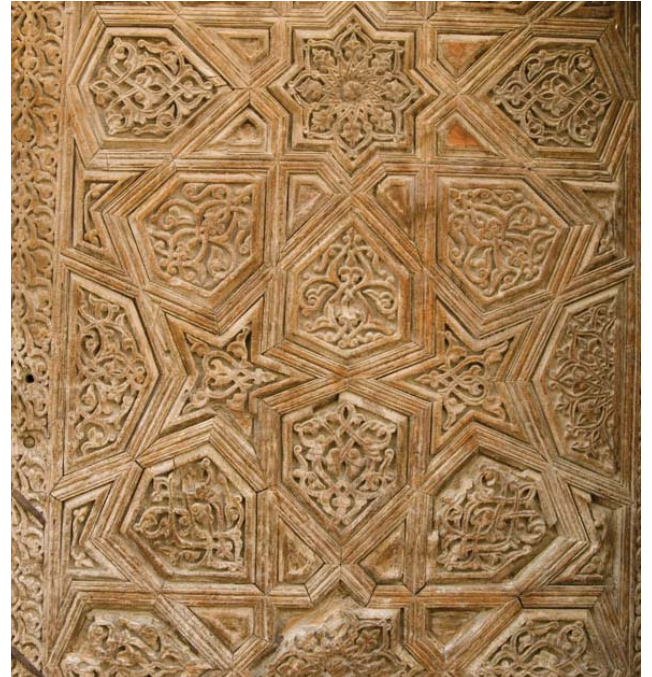
Kapı Detayı

Detail of door

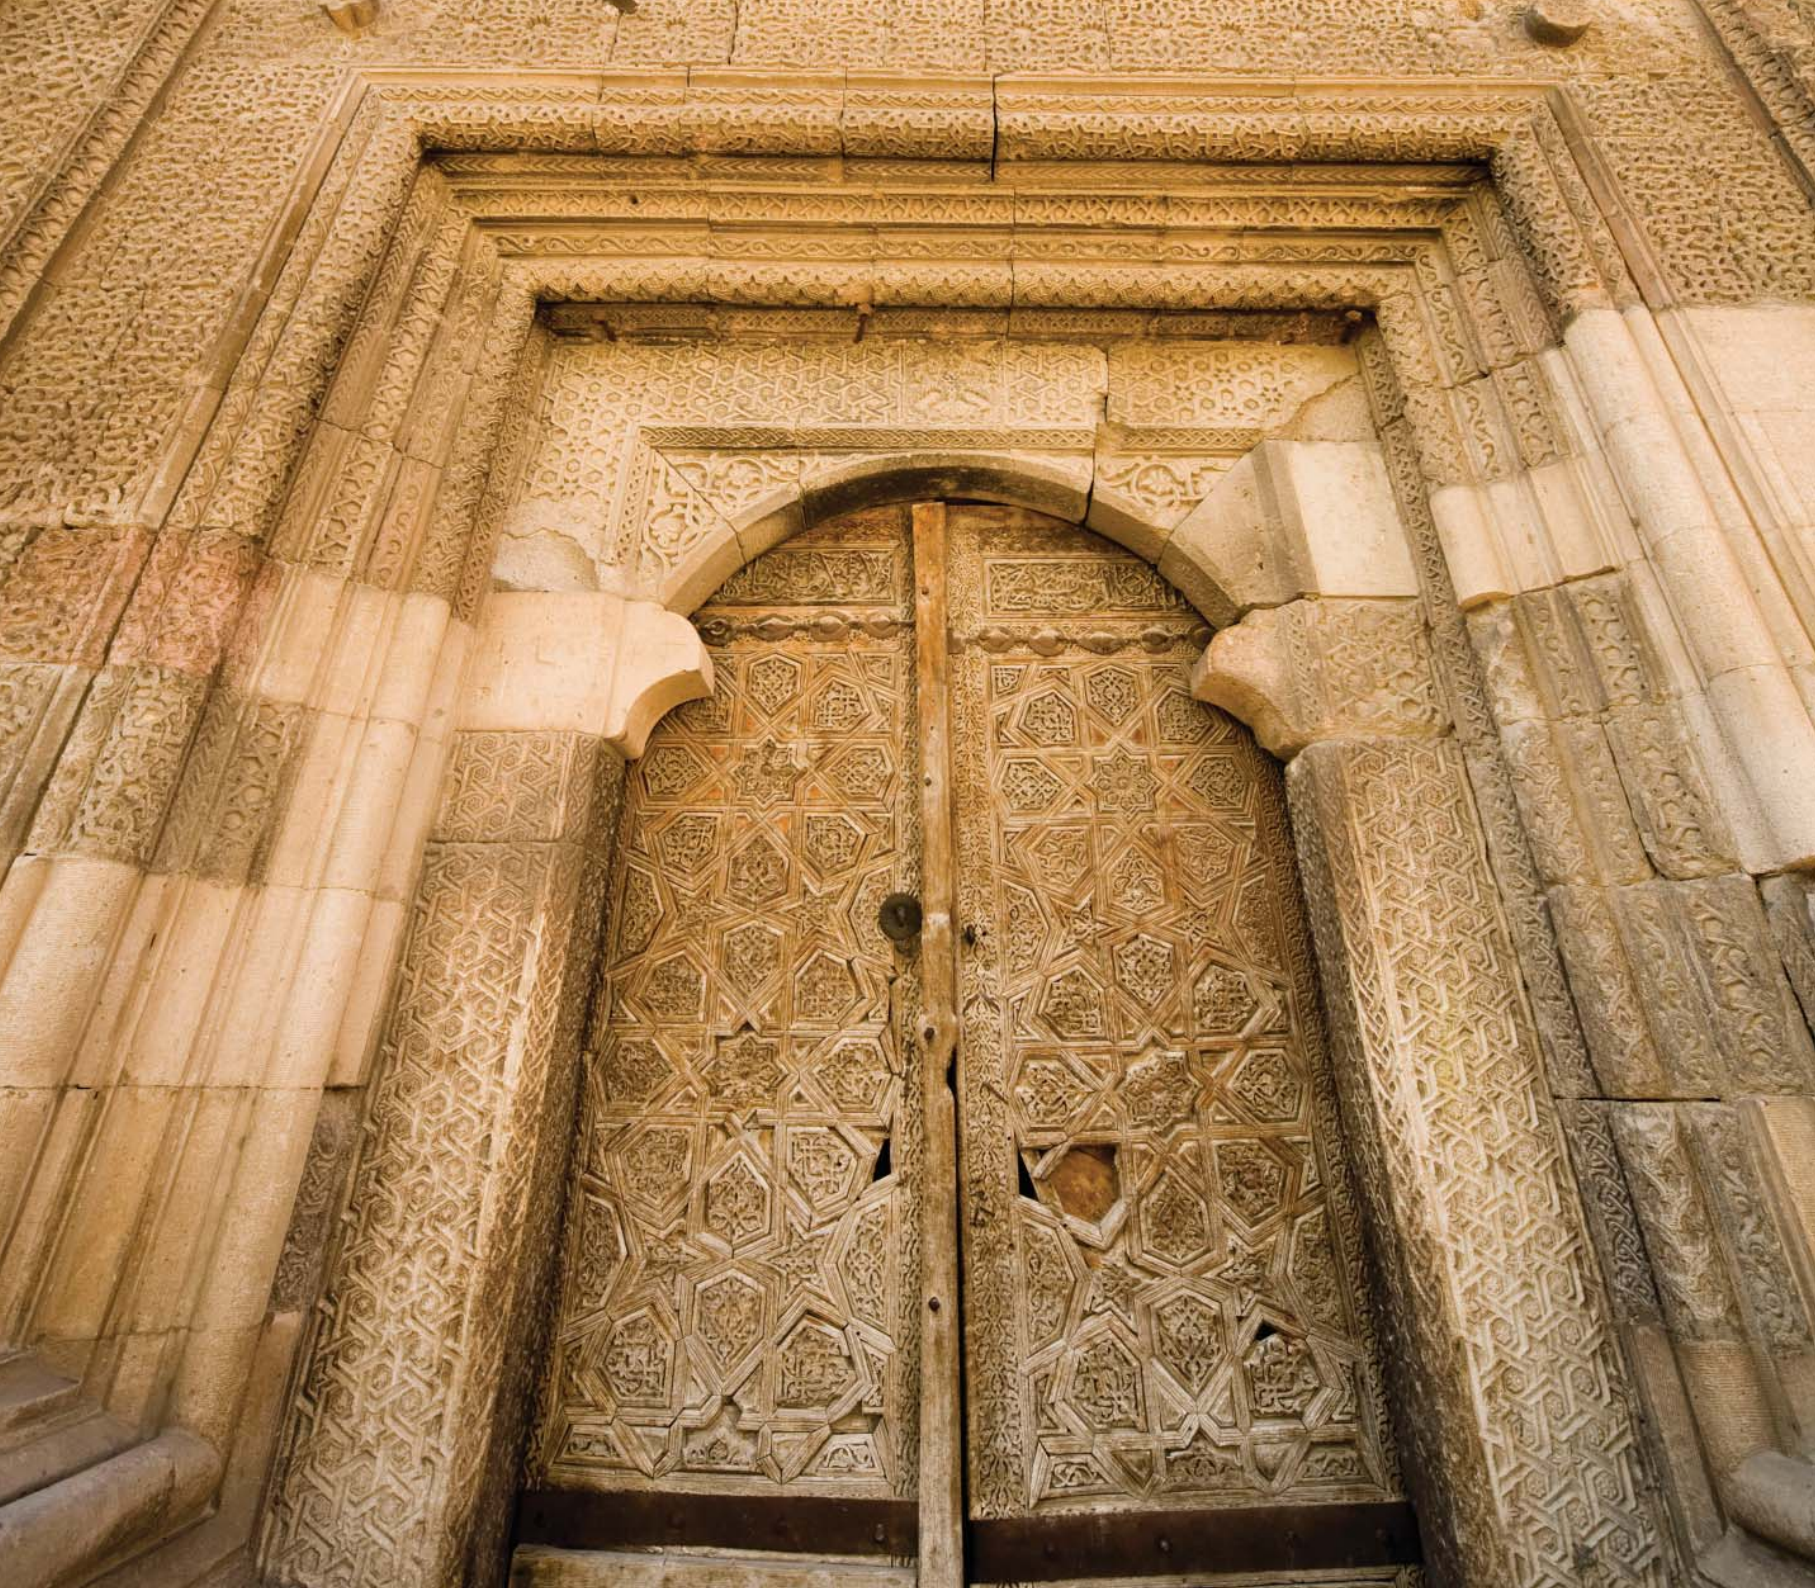
Doğu ve kuzey cephelerde birer taç kapıya yer verilmiştir. Ayrıca kuzey cephenin doğu köşesinde merdivenle çıkılan fevkani, "bey kapısı" vardır.

The east and northern faces have each been given a crown entrance. Also at the eastern corner of the north side there is a staircase leading up to an upper storey "Lord's Entrance".

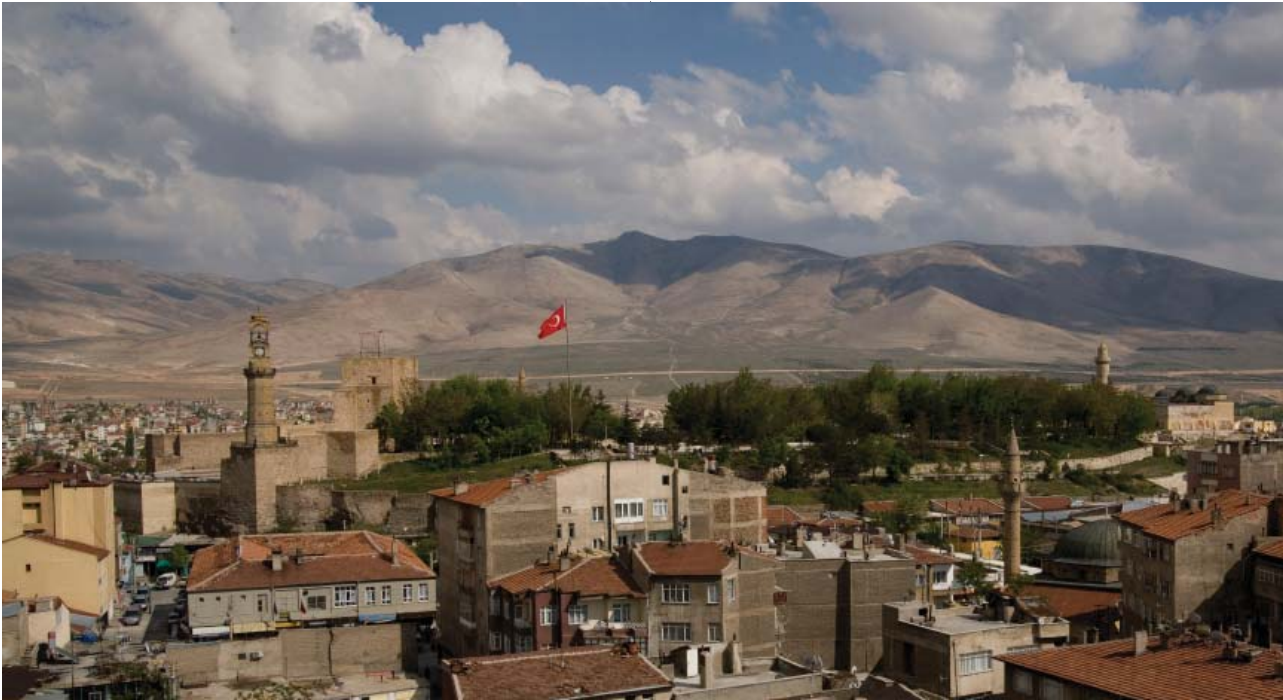
Yüksekten camili görünüm

A view with the mosque from high
